Thermal Safety Tutorial

1 Introduction

Version 2.0 2011

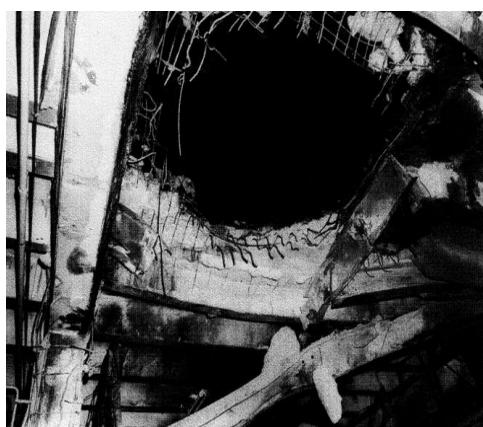
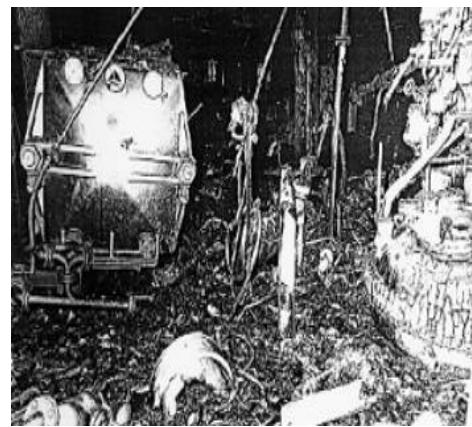
Fig. 1-1 View of the site after a thermal explosion of a reaction vessel
